Post-earthquake seismic reflection survey, Christchurch, New Zealand

ABSTRACT

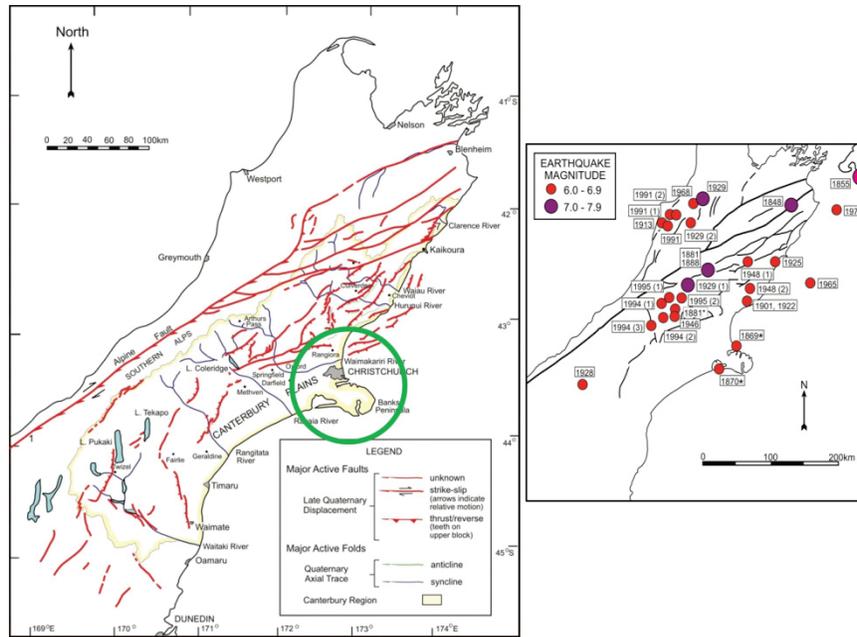
FIG. 2. Tectonic map of the South Island, New Zealand (after Pettinga, 1986).

New Zealand lies in a tectonically active area and straddles the boundary between the Australian and Pacific plates. Figure 2 shows a tectonic map of the south island of New Zealand, with the Christchurch region highlighted in the green circle. The major tectonic feature in the South Island is the Alpine Fault, with numerous splays to the north. The known fault network in the Canterbury Plains region is shown in Figure 2, with most of the faults mapped to the west and north of Christchurch. The epicentres of historical earthquakes with $M_w > 6$ are also shown. Those greater than $M_w 7$ are located close to the Alpine Fault and only 2 earthquakes were known to have occurred near Christchurch since event data had been recorded. Figure 3 shows a geology map of the Canterbury region, showing previously known faults in the west and north of the region, as well as the Greendale Fault that ruptured during the $M_w 7.1$ Darfield Earthquake on September 4, 2010. The epicentres of the 9008 events recorded since September 4, 2010 are shown in Figure 4.

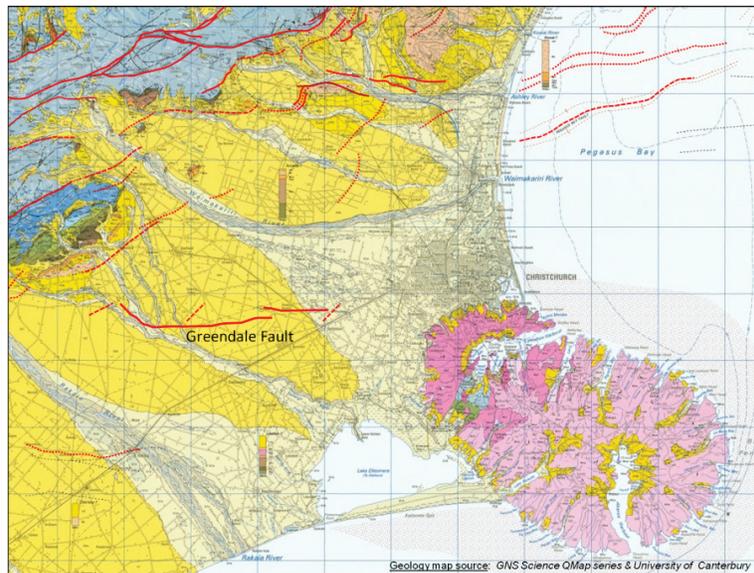
FIG. 3. Geology map of Canterbury region showing faults in red. The Greendale Fault ruptured during the September 2010 Mw 7.1 earthquake (courtesy GNS Science).

Line 3 was located further to the west, and crossed the surface trace of the Greendale Fault that ruptured in the September 2010 earthquake (Figure 3). Recording parameters of the seismic survey are summarised in Table 1 following tests carried out on Lines 1 through 3.

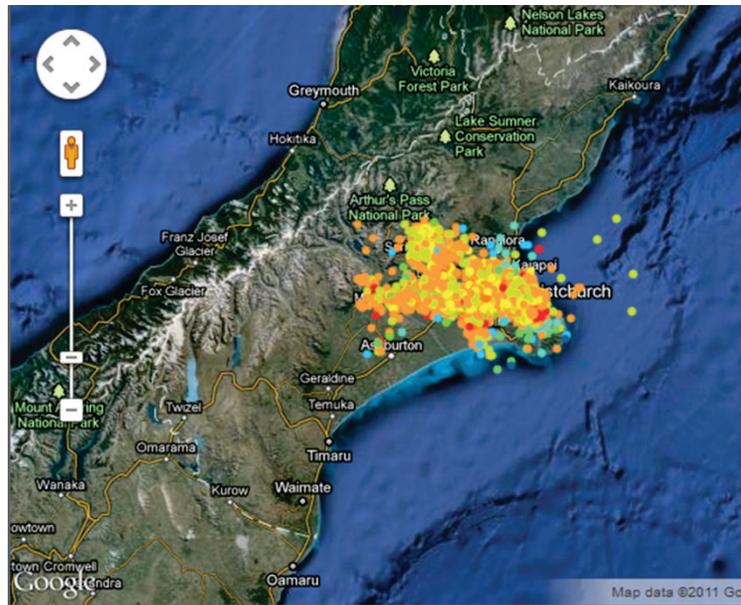
FIG. 4. Epicentres of 9008 events recorded in the Christchurch region since September, 2010. Colour denotes hypocentre depth (ranging from < 2.5 km in red, to > 25 km in light blue). Map data © 2011 Europa Technologies and © 2011 Google and © 2011 Whereis® Sensis Pty Ltd. Imagery © 2011 NASA and © 2011 Terrametrics (Christchurch Quake Map, 2011).

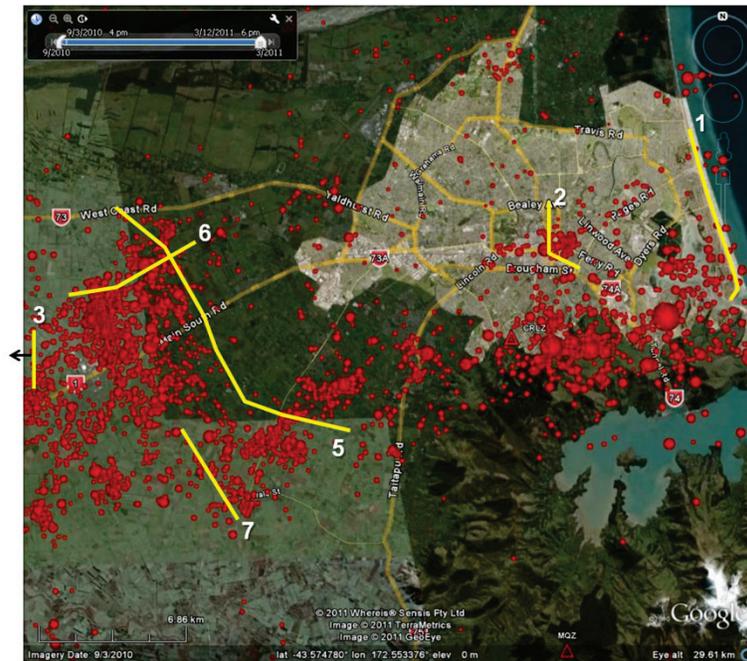
FIG. 5. Layout of 2D seismic lines recorded during the Christchurch seismic program. Red dots show the epicentres of aftershocks through to June 2011 (GNS Science). Line 3 was located 10 km further to the west of position shown. Map data © 2011 Europa Technologies and © 2011 Google and © 2011 Whereis® Sensis Pty Ltd. Imagery © 2011 NASA.

The recording team of Malcolm Bertram, Kevin Hall, Kevin Bertram and Don Lawton made two trips to Christchurch through April and May of 2011 and recorded over 40 line km of high-fold 2D seismic data to map faults below the city. The layout of the seismic lines is shown in Figure 5. Line 1 was recorded along the beach immediately to the east of the city and Line 2 was recorded along one of the main streets near the city centre.

Line 5 was recorded along Robinsons Road and was the first of the seismic lines recorded west of the city, with the goal to provide information about subsurface faults in an area where there is an apparent step-over in epicentres (Figure 5). This line is 16.5 km in length and was laid out along rural roads. Cable crossing of many roads, including State Highway 1 (the main north-south road in the South Island) was accomplished by threading the cable through convenient irrigation culverts that ran under the roads. Along Line 3, the shot interval was nominally 20 m, but this was reduced to 10 m near the southern and northern ends of the line, along trend from the pattern of aftershock epicentres associated with the Port Hills Fault from the east, and the Greendale Fault from the west.

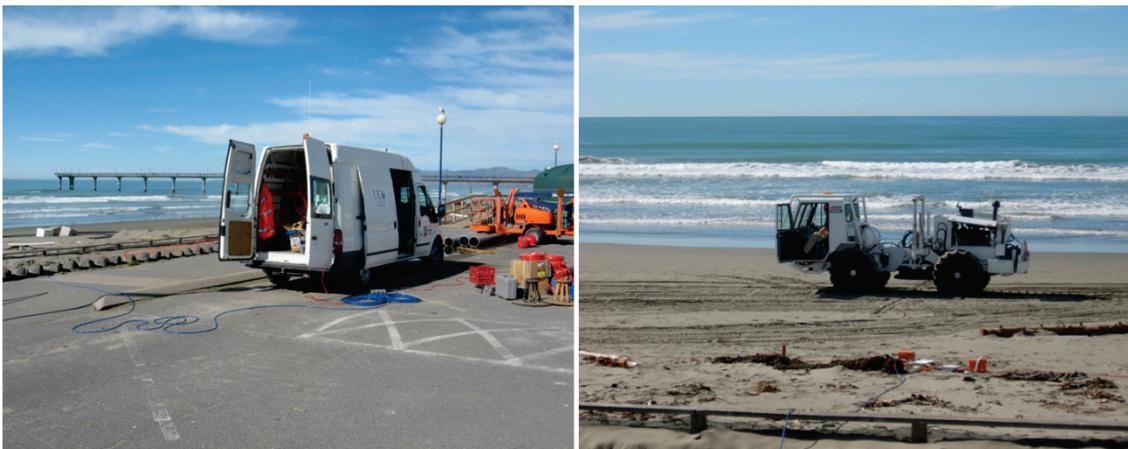
FIG. 6. Recording the seismic line along New Brighton Beach, Christchurch. Recorder van is in left picture and geophone spread is in the foreground of the picture on right.

This was the first line recorded during the survey and the line is located along the Pacific Ocean beach on the east side of the city (Figure 6). It was 8 km in length.

The goal of this line was to image faults that, from aftershock data, were inferred to cross the beach along this line. Recording had some challenges, with soft sand, wave noise and an unexpected tidal surge which drowned the line one evening. Fortunately, the line came up live next day with few issues other than buried geophones and cables, and seaweed entanglements.

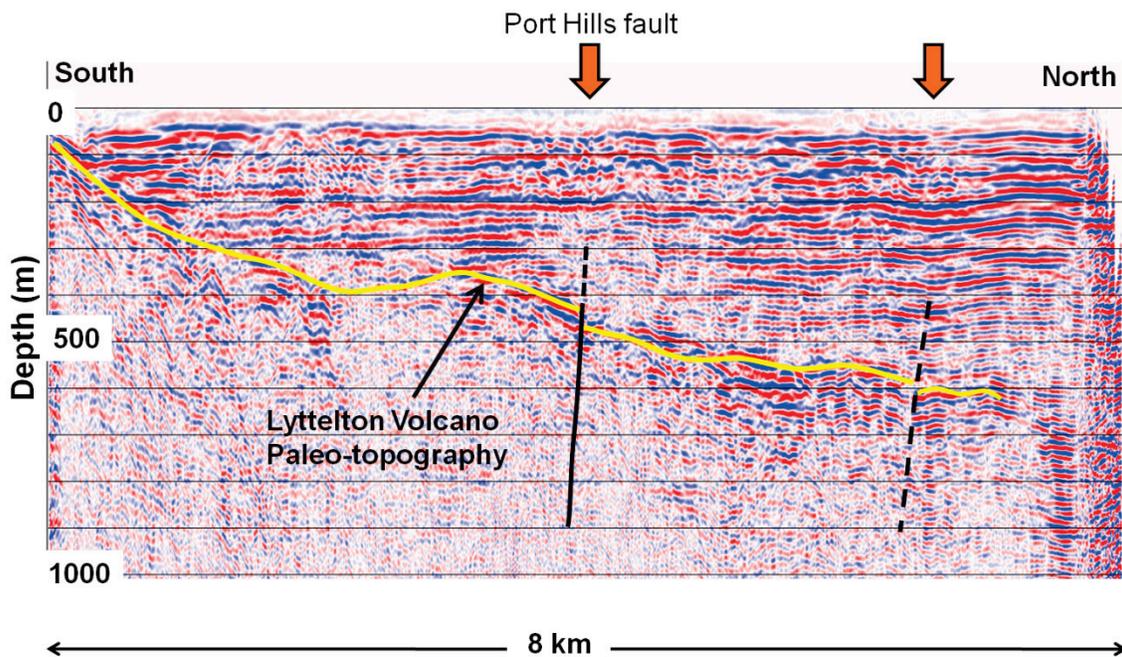
FIG. 7. Interpreted seismic Line 1, along New Brighton Beach.

The interpreted seismic line from Line 1 is shown in Figure 7. The image is dominated by an event that dips from south to north. This is interpreted to be the surface of volcanic rocks from the Lyttelton volcano, the centre of which outcrops southeast of Christchurch (shown in red colour in Figure 3). The seismic section has been converted to depth using a velocity function of 2000 m/s at sea-level to 2800 m/s at 1 km depth.

Because of the limited power of the Envirovibe source, little seismic energy was able to penetrate the volcanic sequence and no reflections could be interpreted below the top volcanic reflector. Discontinuous, near-horizontal reflections from young, unconsolidated sediments lap out against the volcanic interface. These sediments are made up primarily of alluvial to shallow marine sands and gravels deposited from large rivers that have catchments in the Southern Alps to the west.

Two faults are interpreted in this section, identified because of significant offsets in the Lyttelton volcanic events. These faults are considered to post-date the volcanics but pre-date most of the younger sediments as no obvious offsets in reflection patterns can be observed in the sub-horizontal reflections. The fault near the centre of the line occurs on-trend with the Port Hills Fault which was the locus of many aftershocks in the first 6 months of 2011. A second, minor fault is interpreted towards the north end of the line, and coincides with a gentle fold in the sedimentary section, indicating compression from the north.

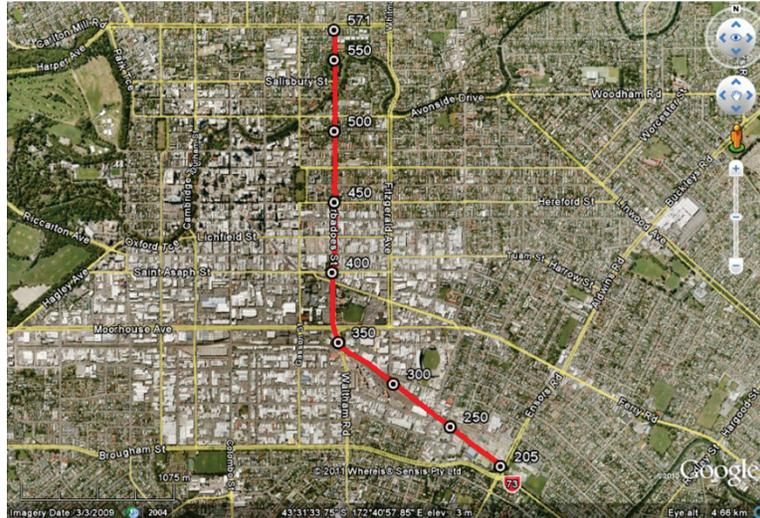
FIG. 8. Location of seismic line 2 – through the city of Christchurch (Barbadoes Street). Map data © 2011 Whereis® Sensis Pty Ltd (Google Earth, 2011).

This line was recorded in the central city (Figure 3), and a detailed view of the line location is shown in Figure 8.

Line 2 is 3.7 km long and was the most challenging of all of the lines surveyed. The southern section trended southeast-northwest and followed a railway line allowance. Challenges along this part of the line included planting geophones and getting good source coupling on the railway ballast. The north-south segment was recorded along Barbadoes Street, a major thoroughfare in the city, although the central 2 km were closed to public access. Challenges along this road included geophone plants in pavement, old sewers and other infrastructure below the road, and the problem of source-points close to damaged buildings and surface infrastructure (Figure 9). Traffic and road-crossings at both the north and south ends of this line also created some difficulties.

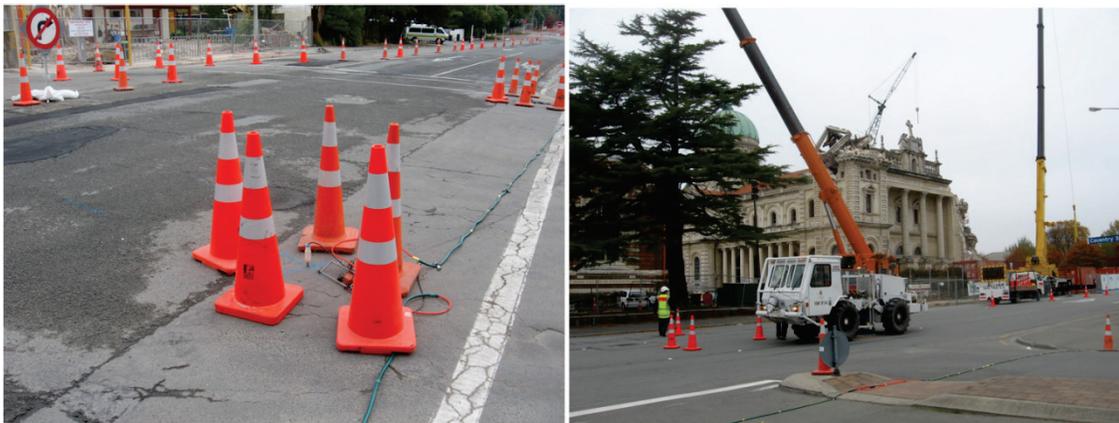
FIG. 9. Seismic acquisition along Barbadoes Street, Christchurch. Geophone plant (left) and source-point outside damaged Catholic Cathedral (right).

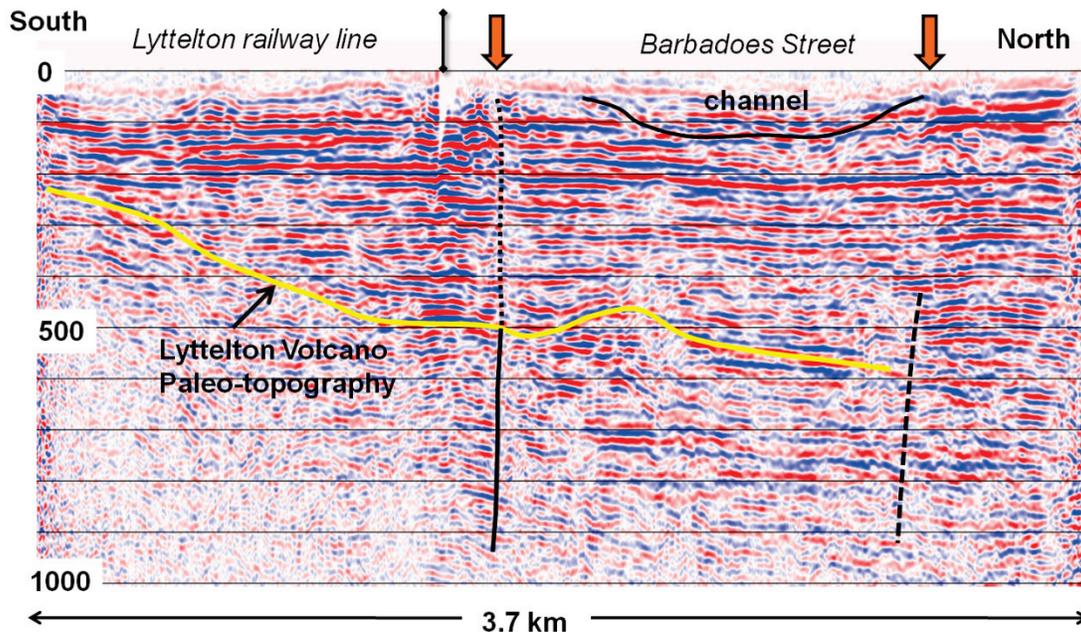
FIG. 10. Interpreted seismic Line 2, along Barbadoes Street

The migrated section from Line 2 is shown in Figure 10. As in Line 1, it shows a reflection from the top of the Lyttelton volcanic dipping to the north and younger sediments lapping out against this surface. Two old faults are interpreted to have minor offsets in the top volcanic event in this section, but displacements are not observed at the ground surface. Towards the north, a shallow channel is interpreted in an area which was heavily damaged due to liquefaction.

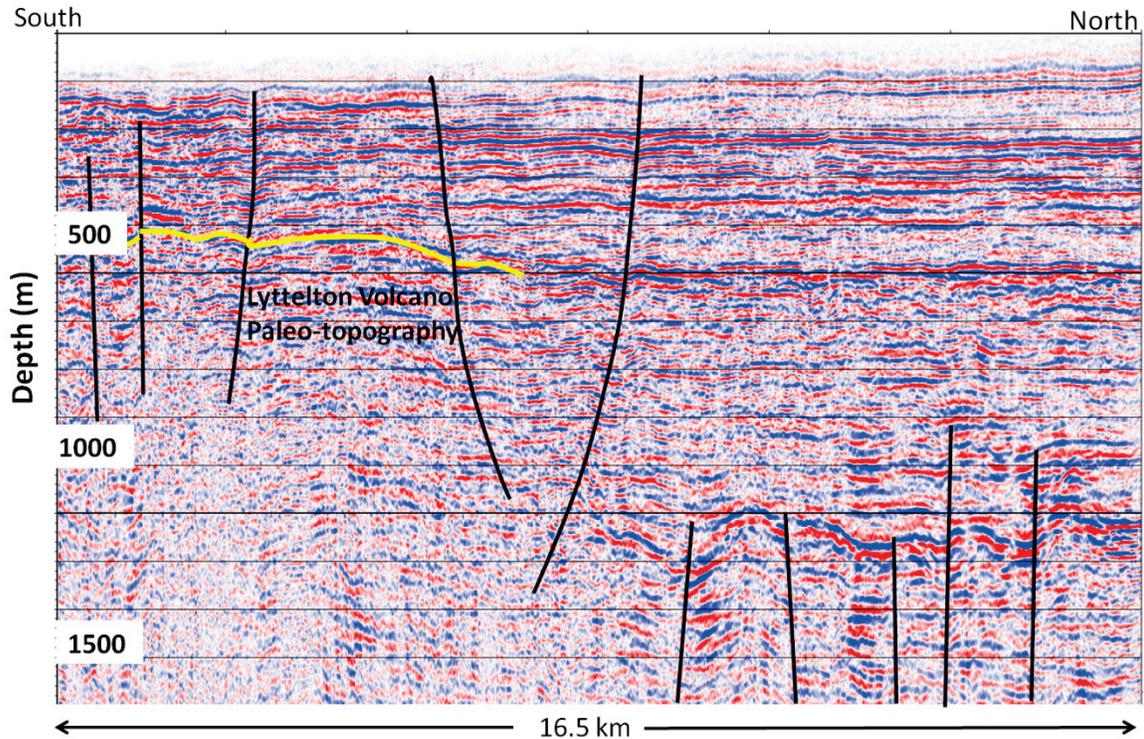
FIG. 11. Interpreted Line 5, linking the stepover between the Darfield and Port Hill Fault systems.

Figure 11 shows an interpretation of Line 5. As in Lines 1 and 2, the top of Lyttelton volcanic paleo-topography is evident (yellow horizon) and links to the north with a flat reflector that is likely due to outflows from the volcano. The volcanic sequence is interpreted to thin to the north since deeper reflections are visible in the northern half of the line; these events are not imaged beneath the thicker volcanics to the south. Two families of faults are interpreted in this section. Shallow, recent faulting is prevalent in the south, and deeper older faults are interpreted in the northern part of the line, with significant structure in the acoustic basement.

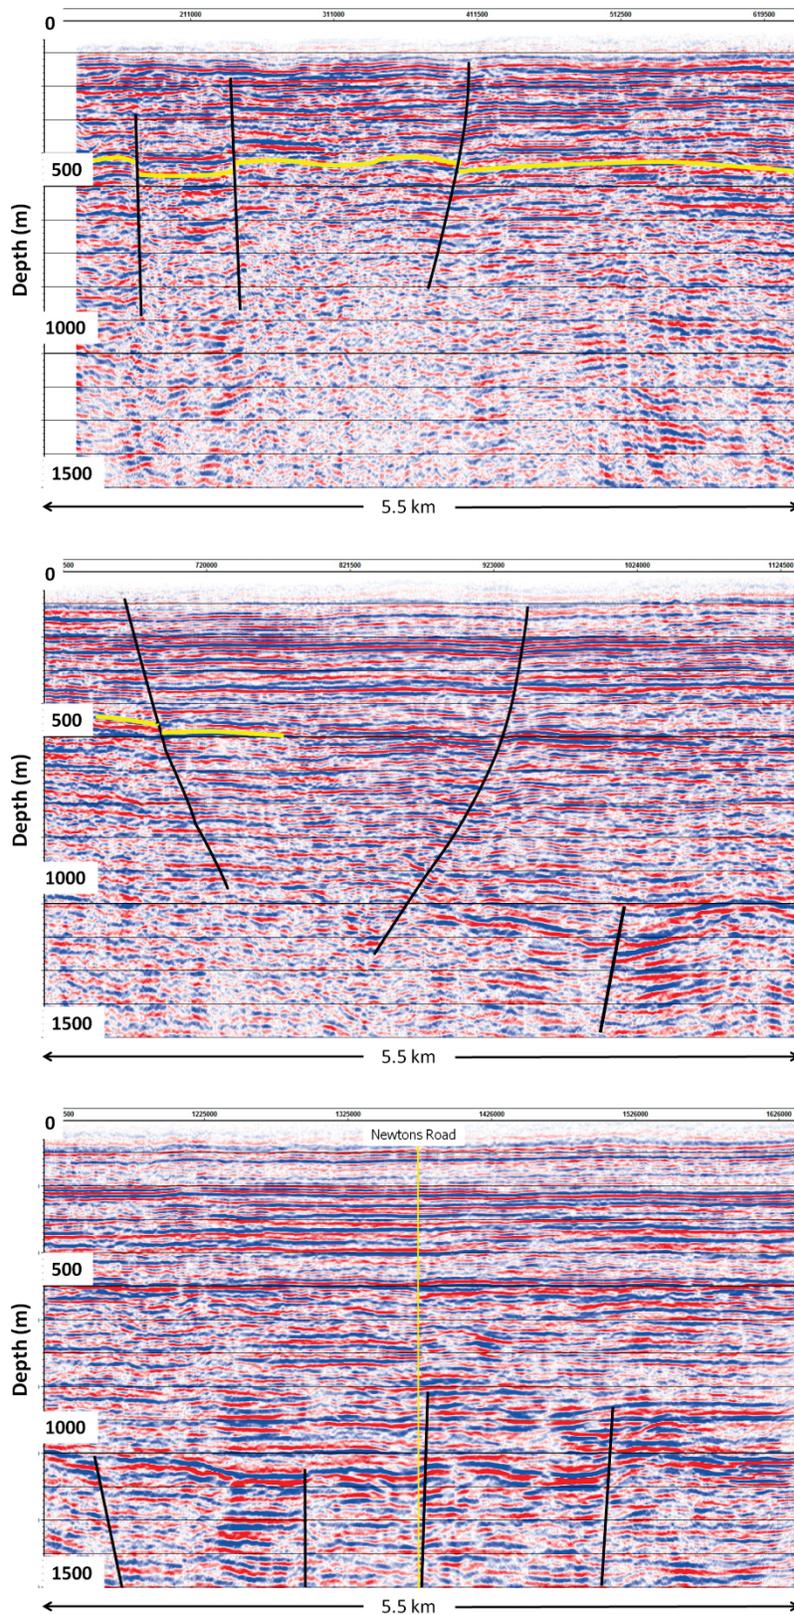
FIG. 13. Segments of Line 5 for detailed interpretation; southern section (top), central section (centre) and northern section (bottom). All sections are south to north from left to right. Tie with Line 6 is shown by the yellow line in the bottom figure.

For a more detailed view of these sections, the line was divided into 3 segments, as located in Figure 12. Figure 13 shows the southern, middle, and northern segments of Line 5.

In terms of risk, the fault in the centre of the seismic line, with a dip to the south, is most significant (Figure 13, centre). This fault has experienced recent activity with the graben feature in the line (Figure 13, centre) showing very shallow displacements in near-surface reflectors. The epicentre of a recent aftershock was located on this fault.

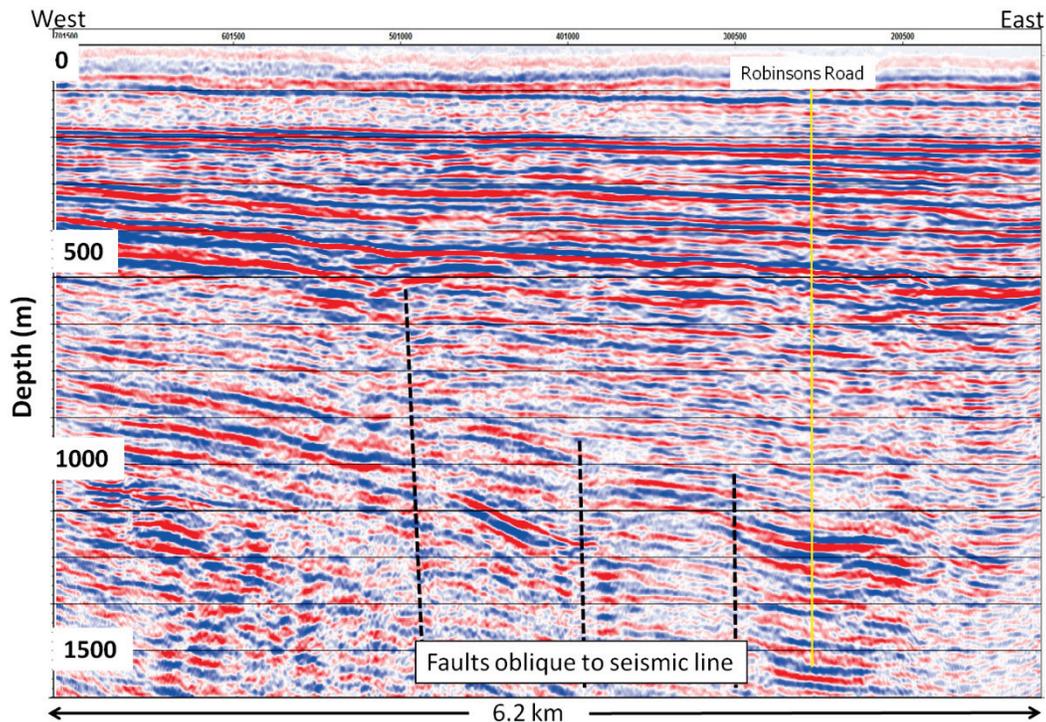
FIG. 14. Interpreted seismic section from Line 6 (Newtons Road). Tie with Line 5 shown (yellow).

This line was located along Newtons Road and was orthogonal to Line 5. It was designed to elucidate, if possible, the 3D geometry of faults in the northern region of the seismic coverage. The interpreted section is shown in Figure 14. Data quality was good and an excellent tie was obtained with Line 5 at the intersection of Newtons and Robinsons Roads. Shallow (< 500 m) reflections (Figure 14) dip gently to the east, toward the depocentre of the young basin. The high-amplitude reflection at ~500 m depth is interpreted to be from outflow deposits of the Lyttelton Volcano. Deeper reflections dip more steeply to the east and 3 faults are interpreted. The lack of clear fault cut-offs and the overlapping behaviour of some of the deeper, discontinuous reflections suggests that the fault trend is oblique to the line of section.

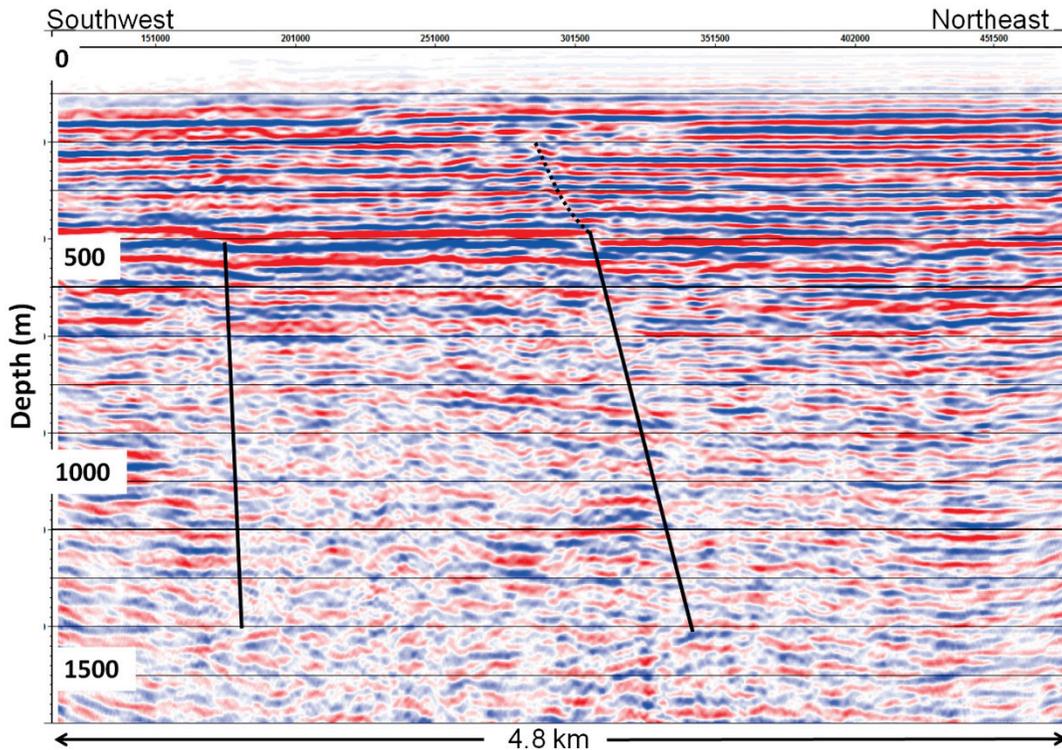
FIG. 15. Interpreted seismic section from Line 7 (Weedons Road).

Line 7 was 4.8 km in length, located along Weedons Road. The goal of this line was to map the possible extension of the Port Hills Fault and related fault systems further to the west. Two faults were interpreted along this line (Figure 15), but offsets of reflections across the faults are generally small and do not appear to reach the present ground surface. However, the fault near the centre of the line shows possible incipient displacement into the shallow section (above the Lyttelton volcanic surface at ~500 m

depth), and loss of very shallow reflectivity above this fault is interpreted to be evidence of liquefaction which was known to occur along this line during the Darfield earthquake.

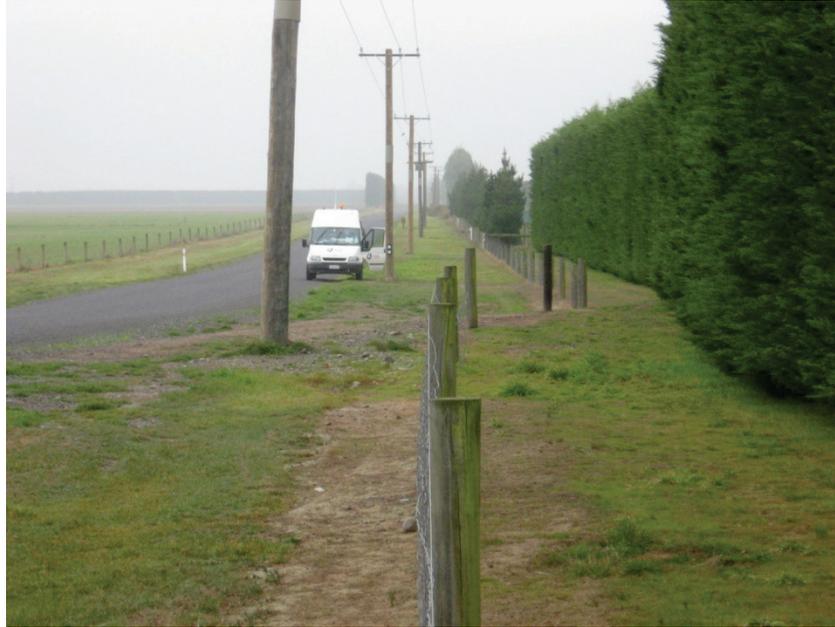
FIG 16. View along Highfield Road. showing lateral & vertical offsets across the Greendale Fault.

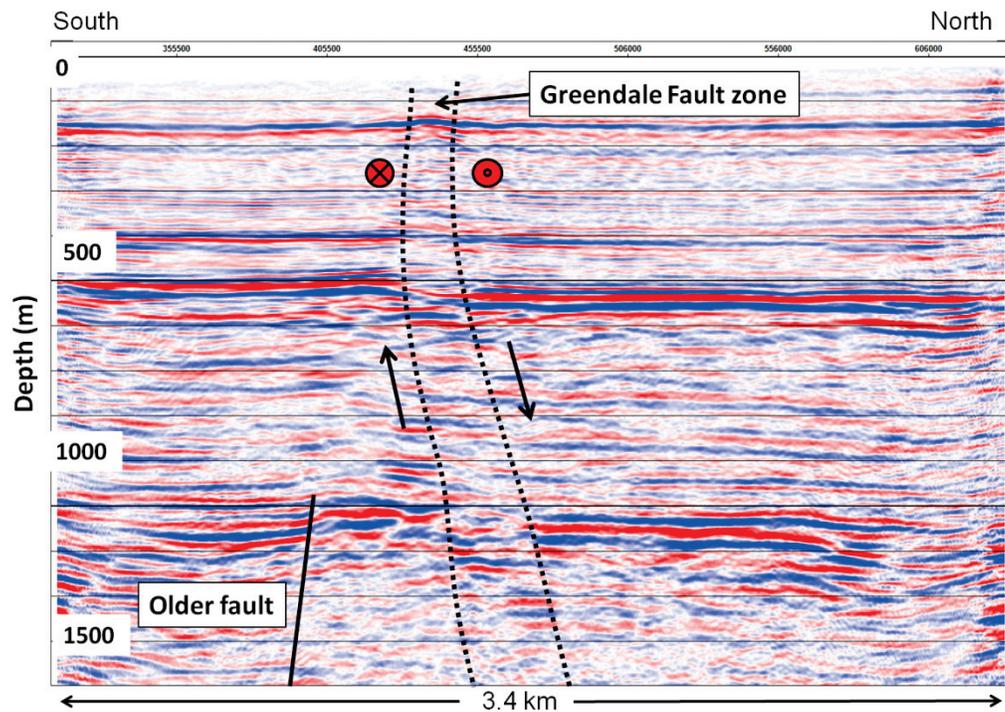
FIG. 17. Interpreted seismic section from Line 3 (Highfield Road).

Figure 17 shows the interpreted seismic image across the Greendale Fault. The fault zone is quite wide (~200 m) and deeper events show loss of reflectivity within the fault zone. It is interpreted to dip to the north, consistent with observations from moment tensor analysis of the fault displacement and fault plane orientation (Quigley et al., 2010). The increasing reflector offset with depth suggests that this fault has indeed been active

in the geological past, even though no surface evidence for it has been documented throughout the time that this region has been settled. The deep reflector (1200 m) also has an older fault interpreted to offset it, creating a horst feature.

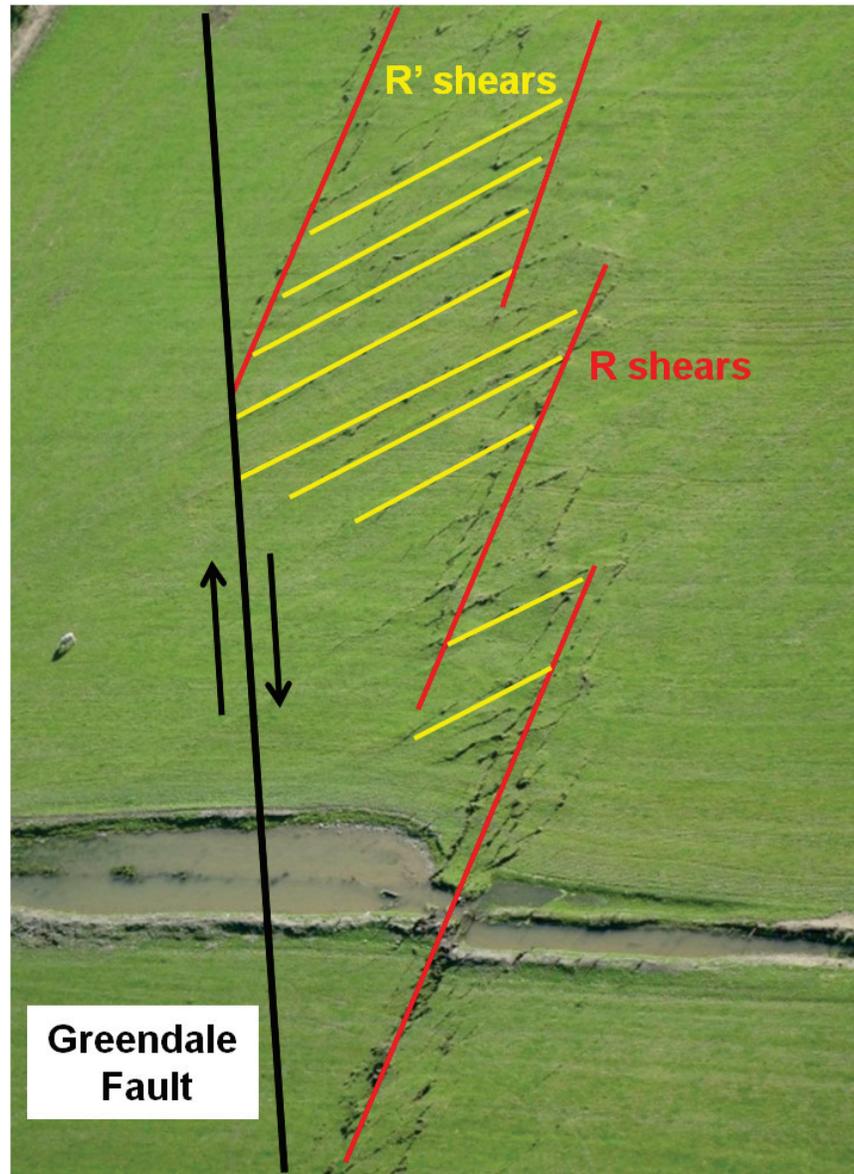
FIG. 18. Greendale Fault and conjugate Riedel shears R and R' (after Quigley et al., 2012).

One explanation for the observed width of the Greendale fault zone is illustrated in Figure 18. This shows a photograph of the Greendale fault surface rupture soon after the earthquake, showing several parallel to sub-parallel faults (red) linked by Riedel shears (yellow). Riedel shears are commonly found in transpressional environments and develop as a result of simple shear during the early stages of fault development (Katz, et al., 2002).

If deformation continues, the fault system commonly forms a flower structure, where the individual fault segments tend to merge at depth. On Line 6, the fault zone tends to widen slightly with depth, so the individual faults must merge at significantly greater depths than imaged on the seismic data.

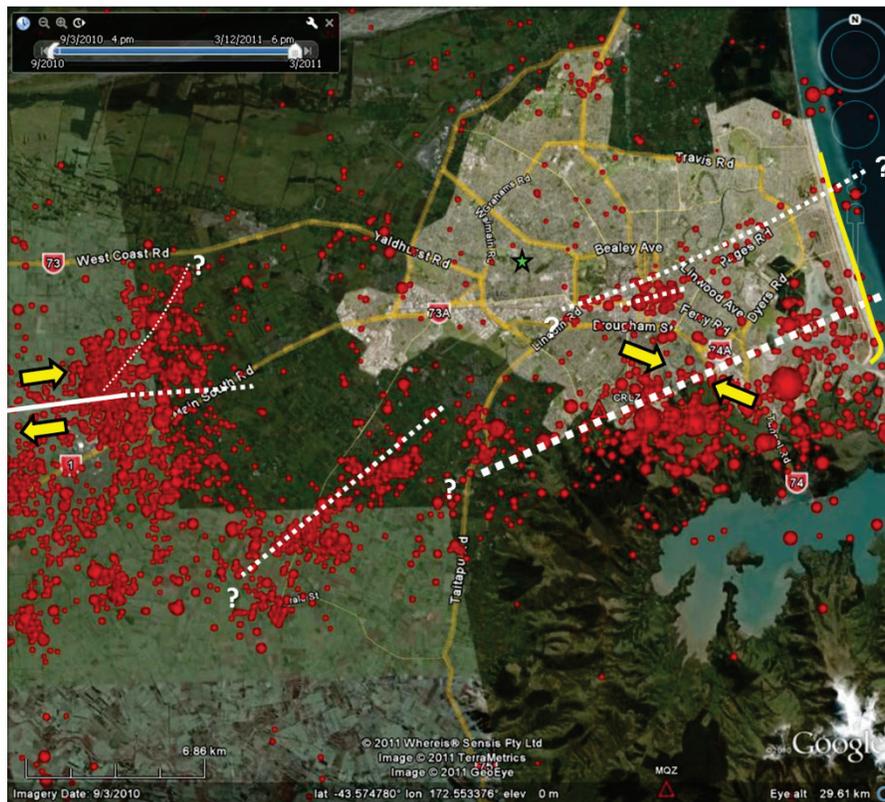
FIG. 19. Fault systems in the Christchurch area interpreted from the seismic reflection survey and the distribution of aftershock epicentres, shown by the filled red circles. Map data © 2011 Europa Technologies and © 2011 Google and © 2011 Whereis® Sensis Pty Ltd. Imagery © 2011 NASA

The seismic program in the Christchurch region has successfully delineated a number of faults that were previously unknown. The general pattern of the fault systems in the area is shown in Figure 19, identified by the dashed white lines. Only the Greendale Fault ruptured to surface (solid white line). The faults identified through the seismic program are interpreted to be near-surface (< 1.5 km) expressions of deeper faults that are the loci of aftershock hypocentres shown in Figure 19. The hypocentre of the Darfield Earthquake is reported to be at a depth of 10.4 km (Gledhill et al., 2011).
